Wascana Centre Authority

Comprehensive Review Project

Building and Infrastructure Assessments

September 2012

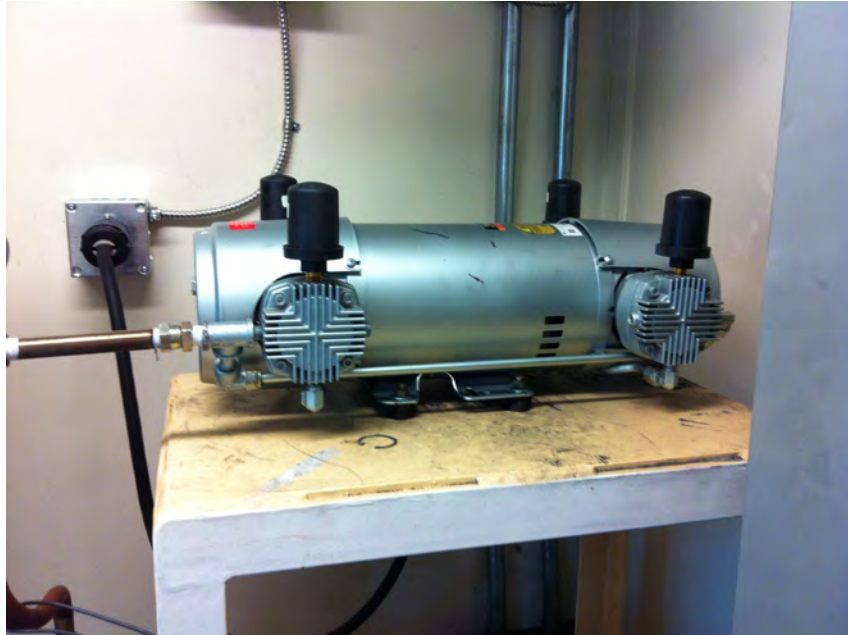
Aeration Equipment-Detail-Interior

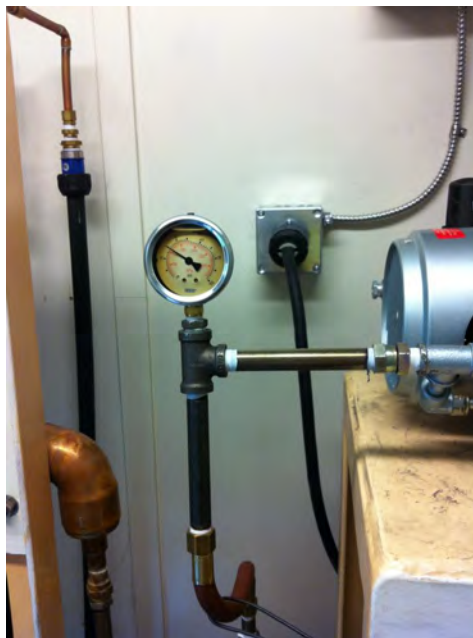
Pressure Gauge-Detail-Interior

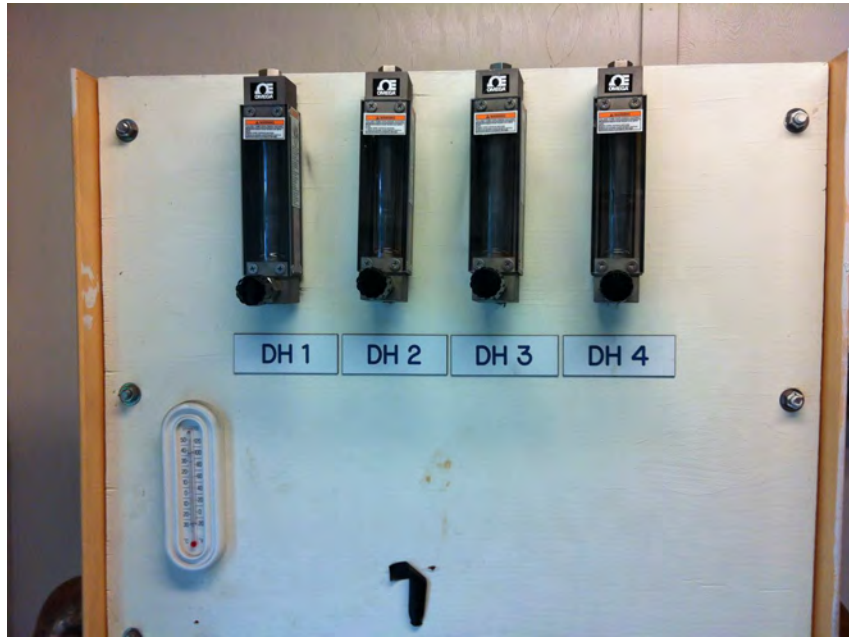
Rotatmeters-Detail-Interior

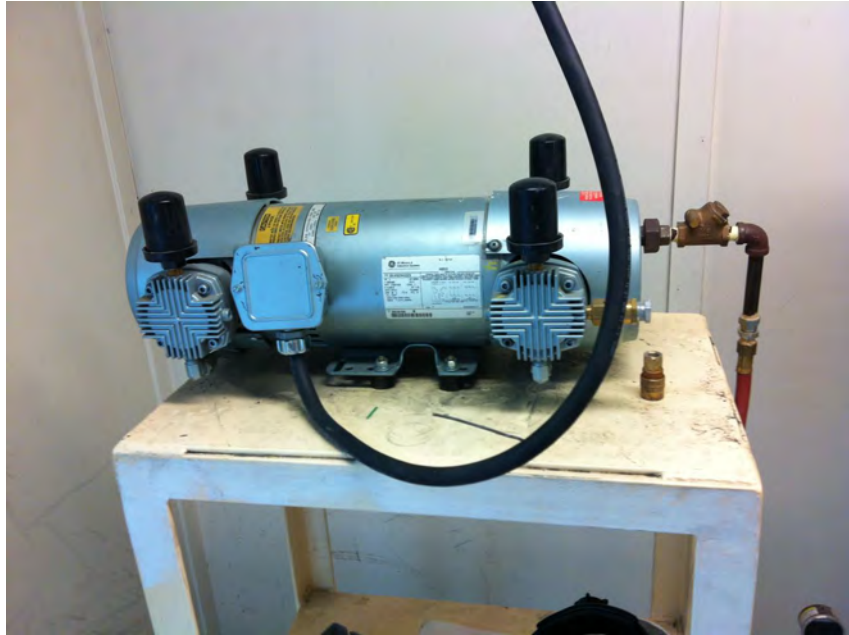
Aeration Equipment-Detail-Interior

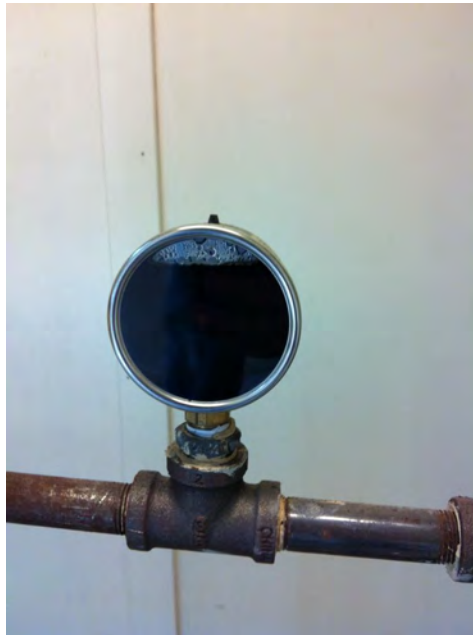
Pressure Gauge-Detail-Interior

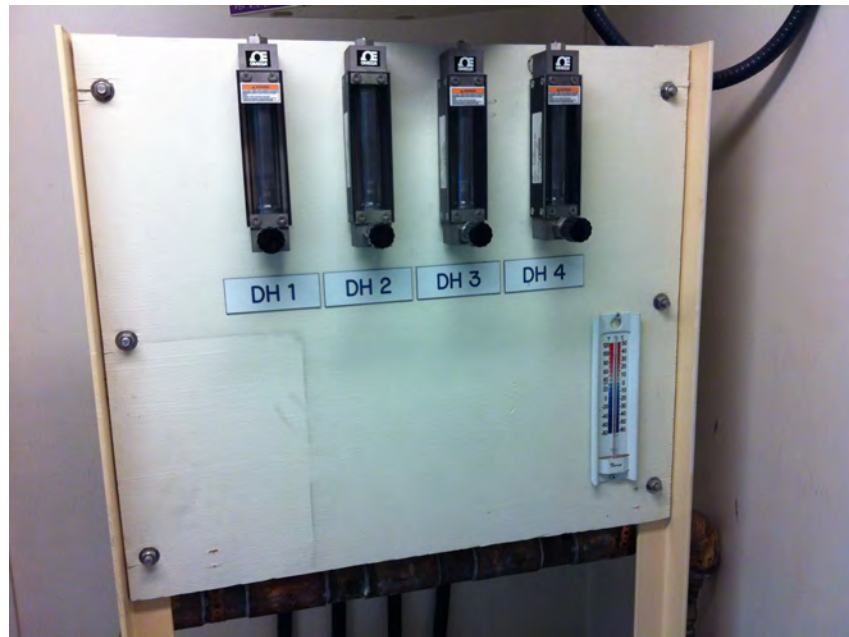
Rotameters-Detail-Interior

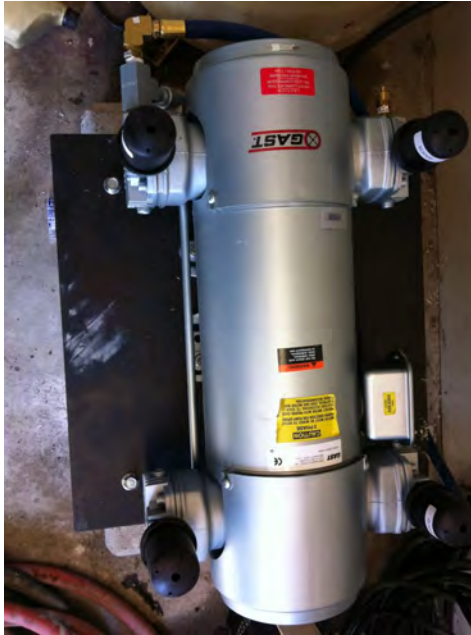
Aeration Equipment-Detail-Interior

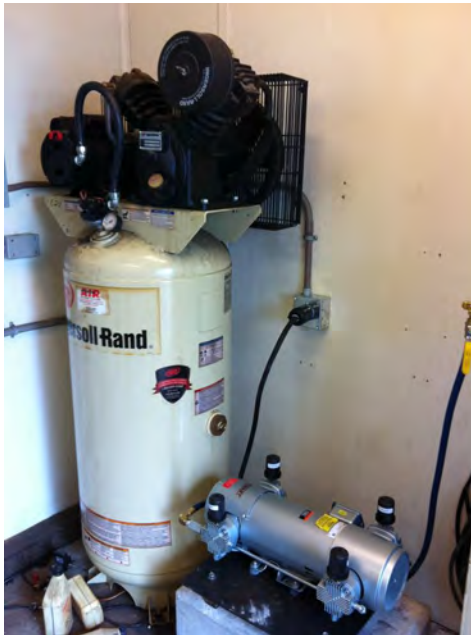
Air compressor & Air Receiver-Detail-Interior

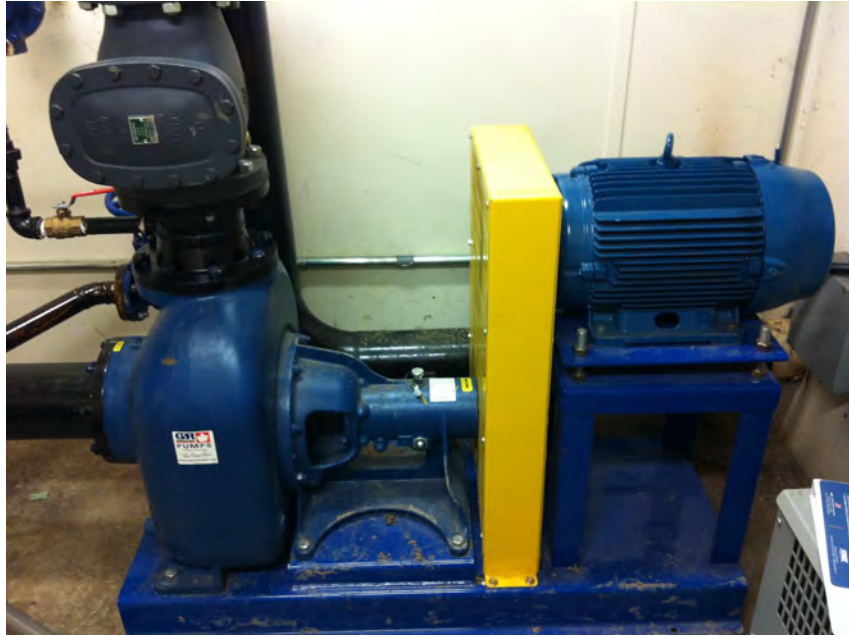
Waterfall Pump-Detail-Interior

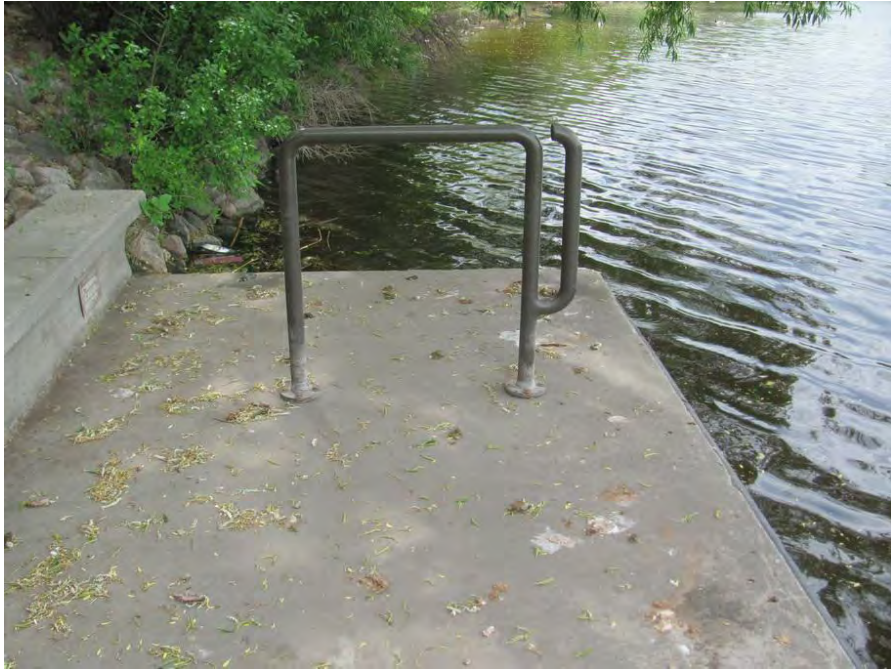
Dockposts1-Detail-Exterior

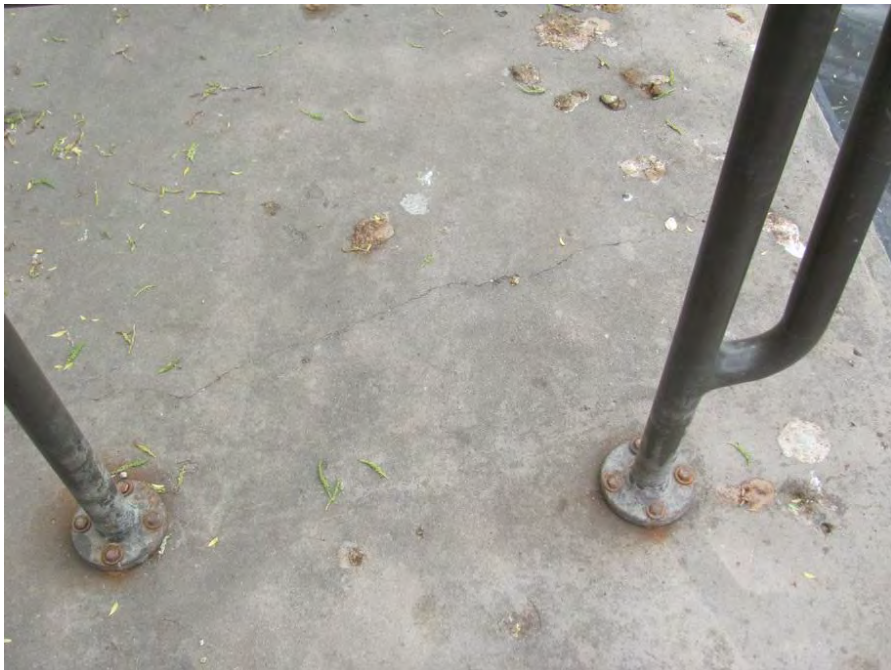
Dockposts2-Detail-Exterior

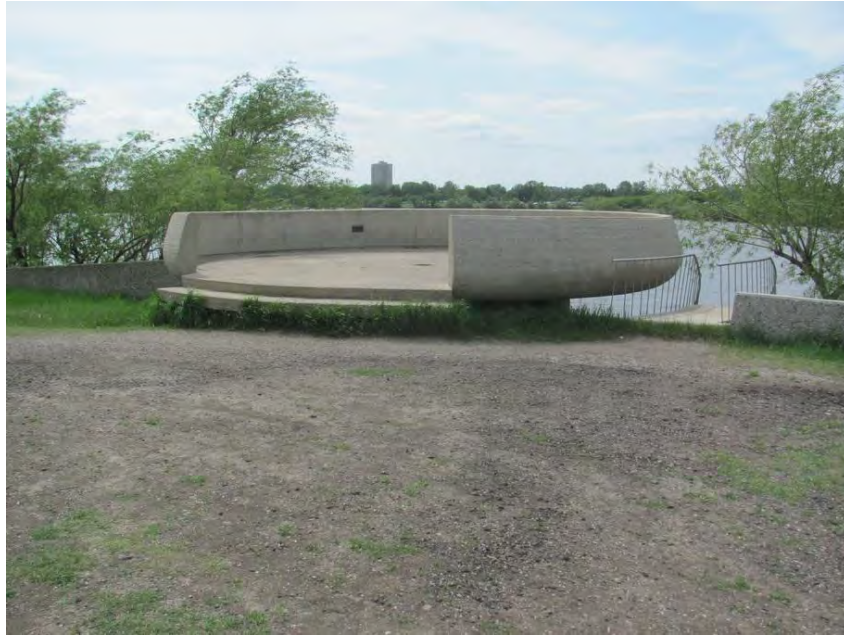
Approachsurface-Detail-Exterior

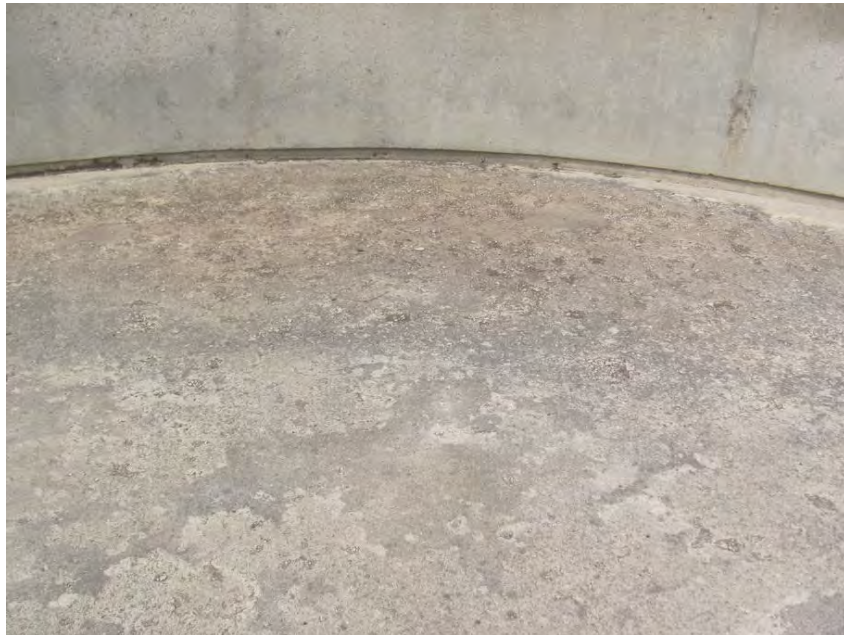
Overlooksurface-Detail-Exterior

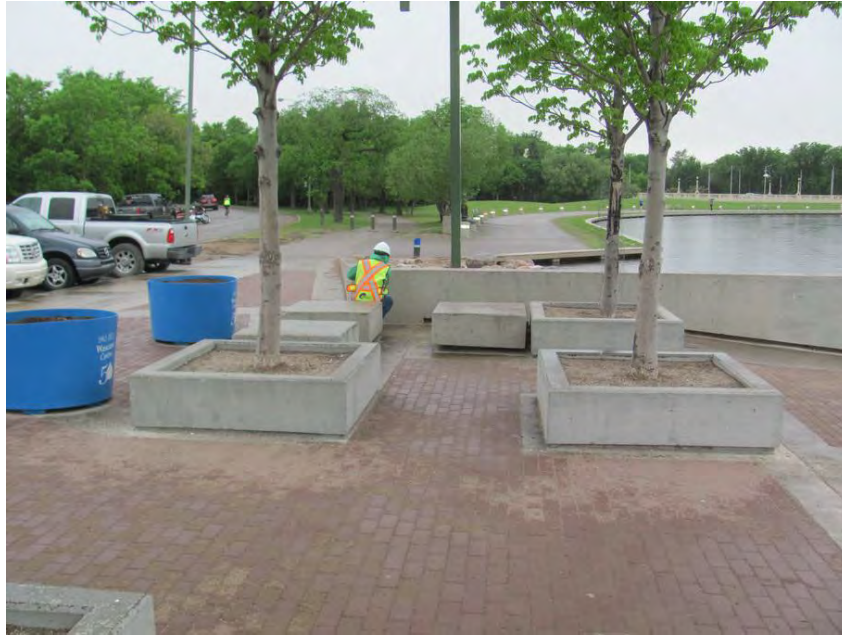
Bricksurface1-Detail-Exterior

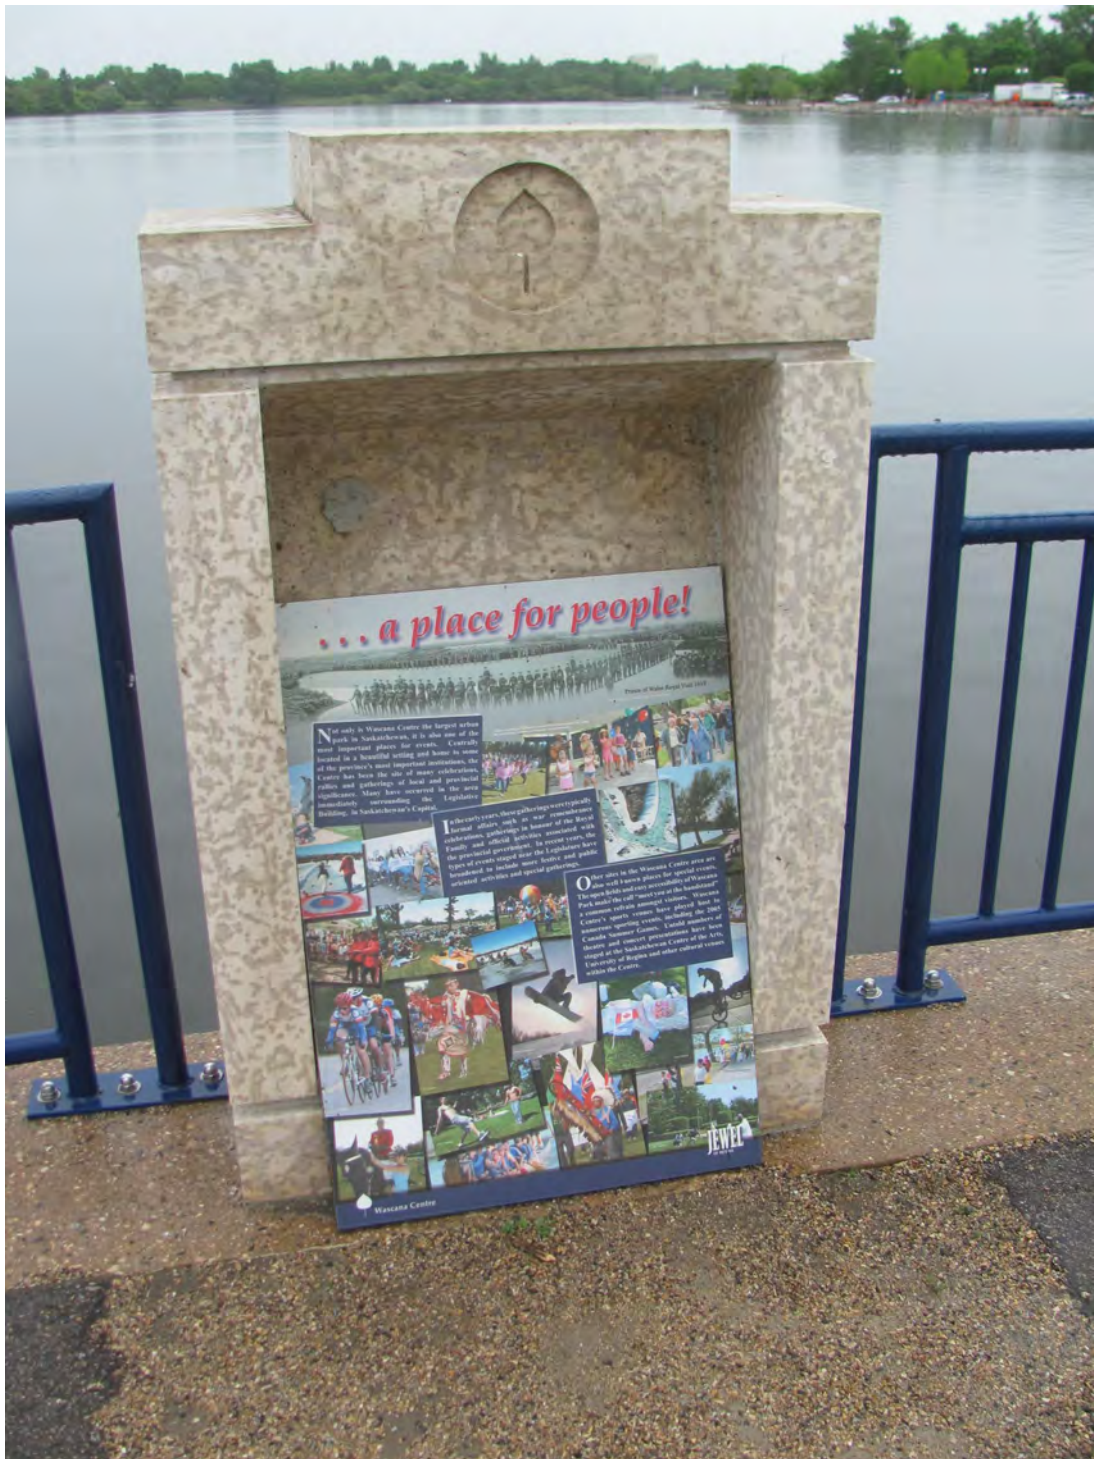
Overlookpicture-Detail-Exterior

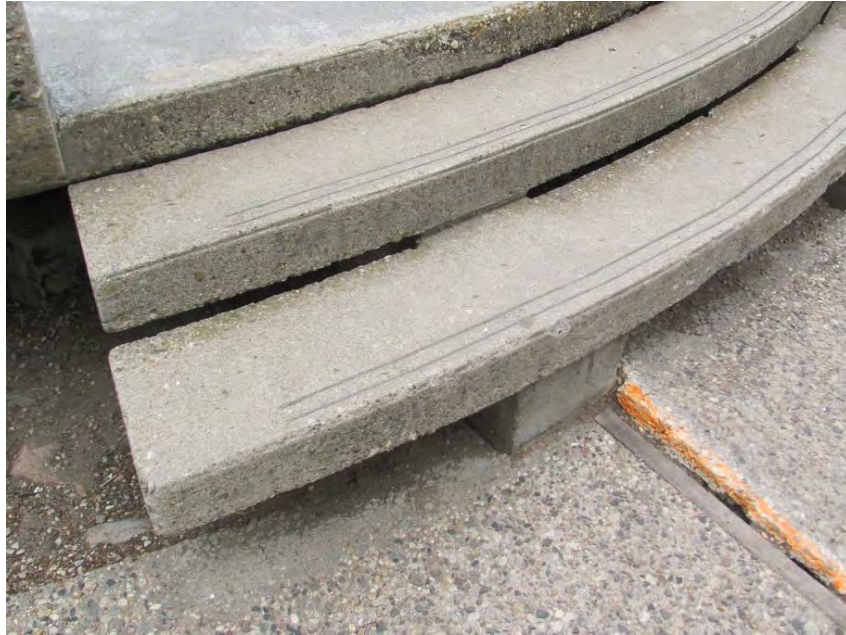
Approachslab1-Detail-Exterior

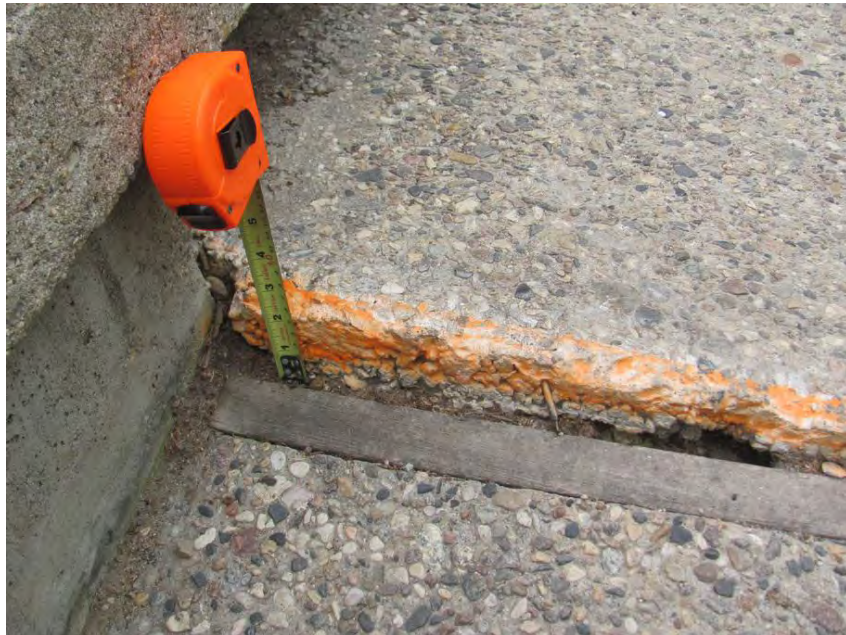
Approachslab2-Detail-Exterior

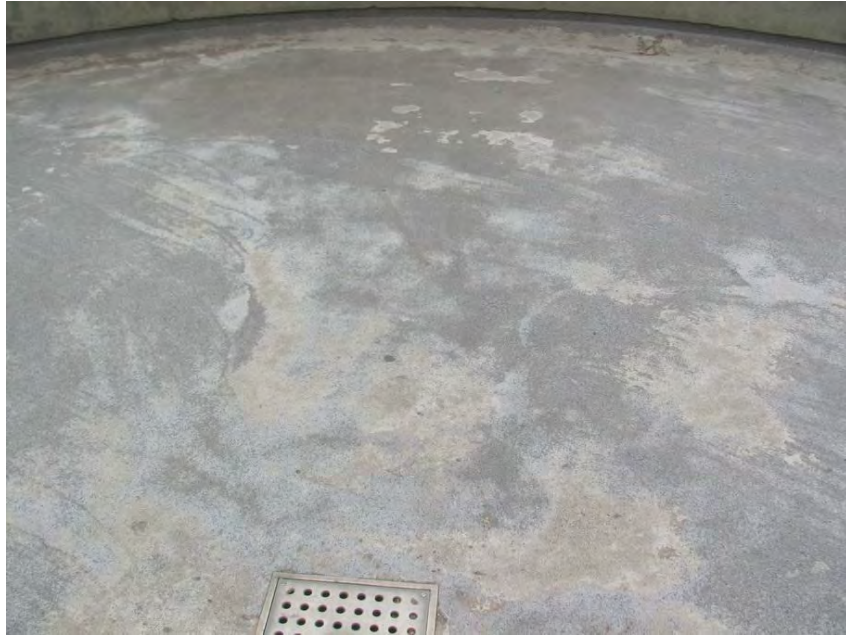
DeckSurface-Detail-Exterior

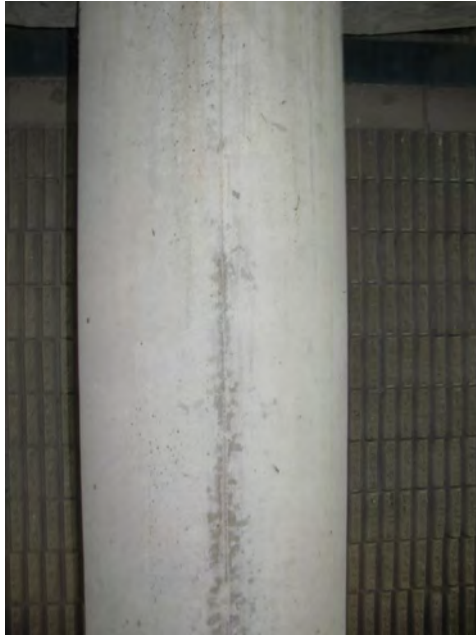
Bugholes-Detail-Exterior

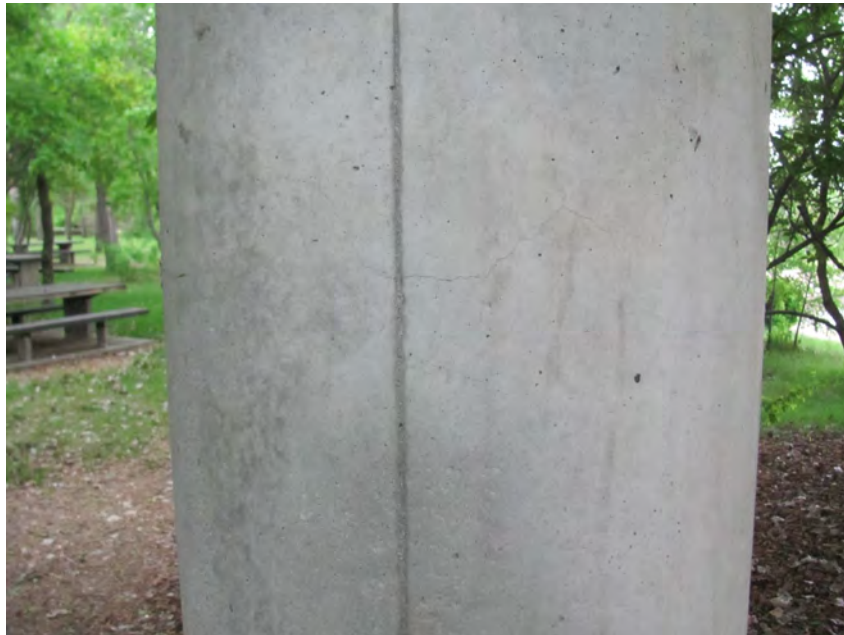
Bugholes2-Detail-Exterior

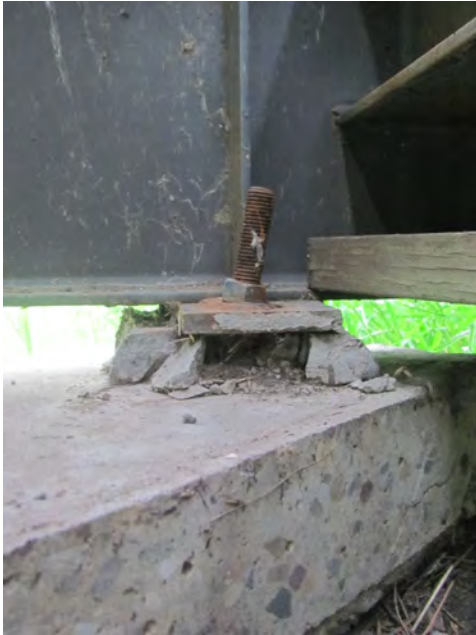
Bearingplate-Detail-Exterior

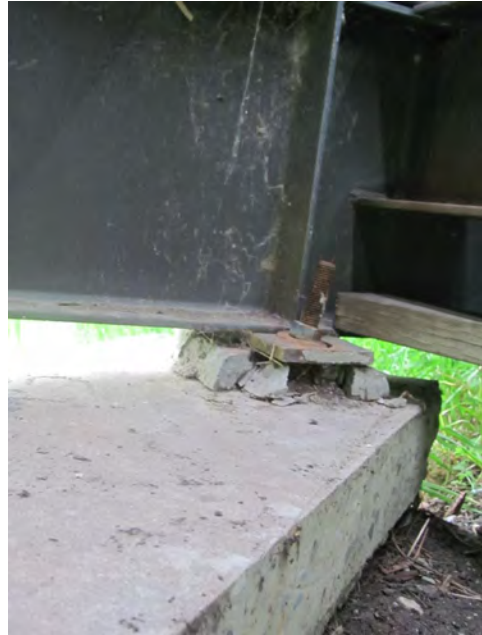
FoundationWall-Detail-Exterior

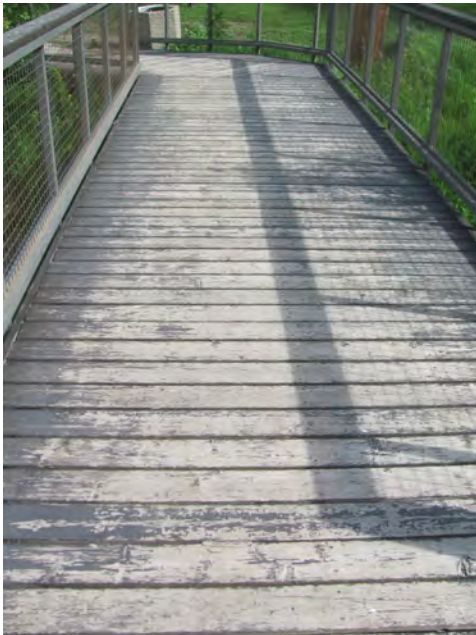
Paint-Detail-Exterior

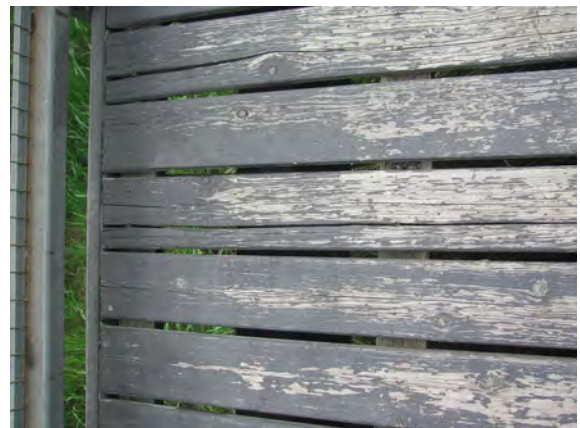
Paint2-Detail-Exterior
